THE UNITED STATES  
STRATEGIC BOMBING SURVEY

EFFECTS OF  
THE ATOMIC BOMB  
ON  
NAGASAKI, JAPAN

Physical Damage Division

June 1947

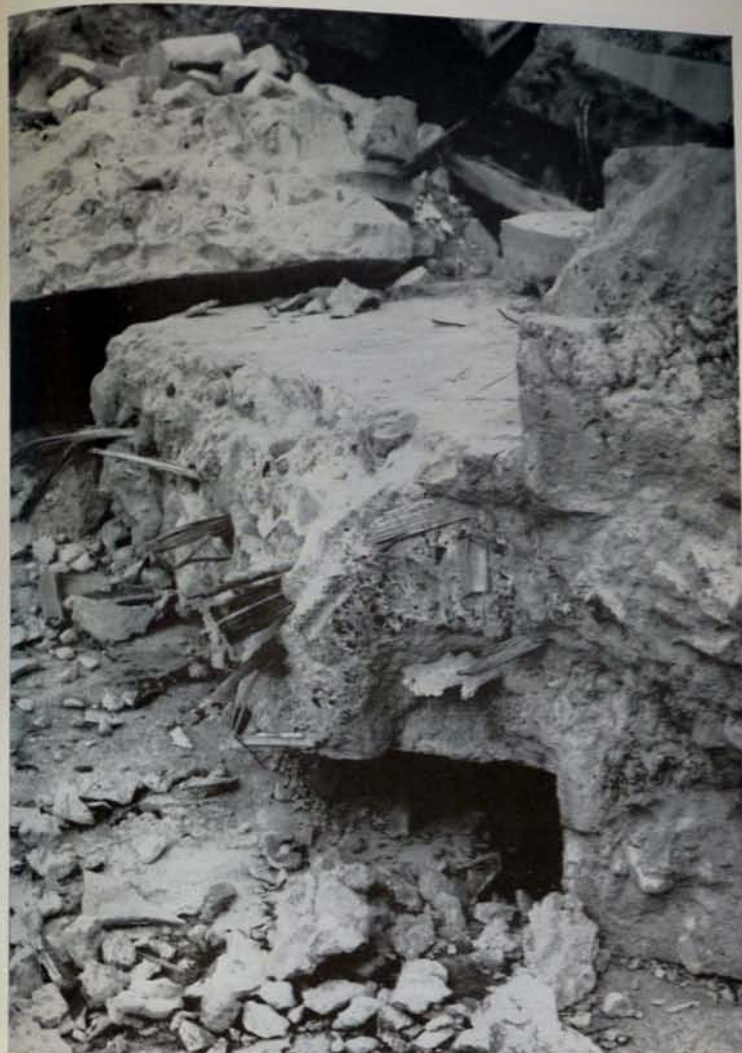
These buildings completely destroyed by blast and fire. Photos 162 and 163.

PHOTO 163.—4,800 feet from GZ. Group 26, Building 40. Fallen 14-inch bamboo reinforced concrete walls. Typical of building methods used in unimportant buildings and in retaining walls.

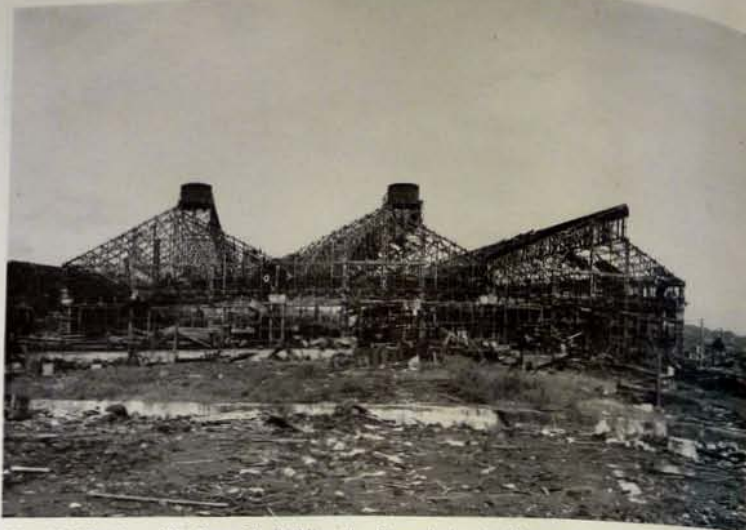
Photo 164.—4,300 feet from GZ. Group 26, Building 41. General view, looking north. Corrugated siding and roofing was stripped, but the building was structurally undamaged.

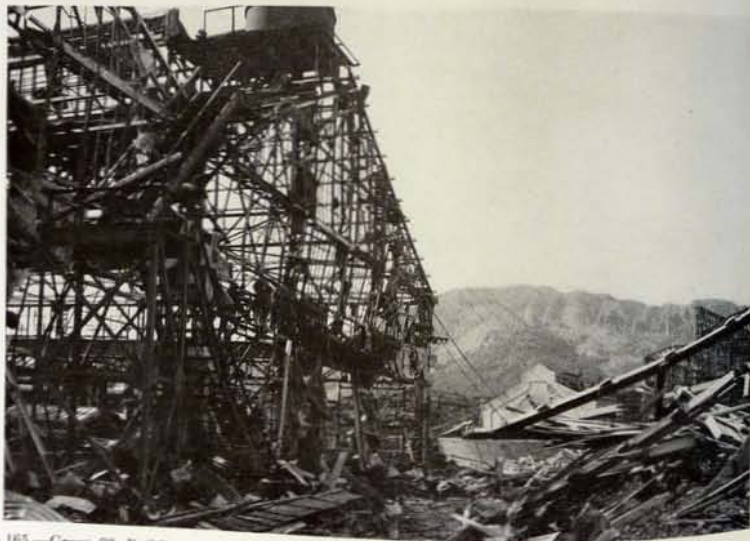
Photo 165.—Group 26, Building 41. Northwest corner of building, showing effect of blast on steel stair. Note the undamaged tank on the roof.

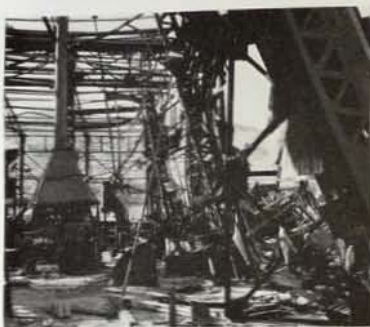
PHOTO 169.—Group 31, Building 1. Looking west along north column line.

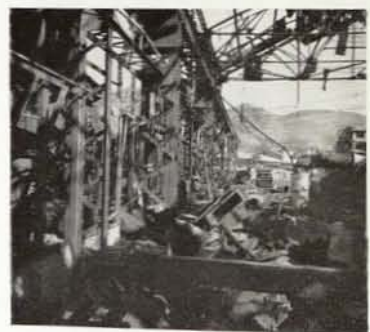
Remarks: Photos 170 and 171.

PHOTO 171.—Group 31, Building 8. Looking east along north row of columns.

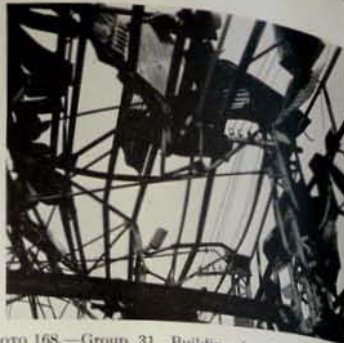
PHOTO 168.—Group 31, Building 1. Looking north at typical truss failure.

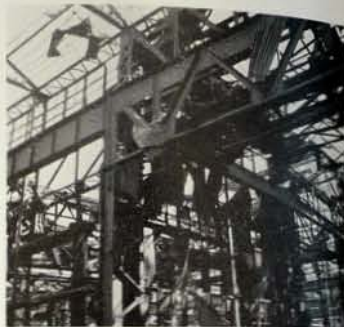
PHOTO 170.—Group 31, Building 8. Looking southeast at crane girder.

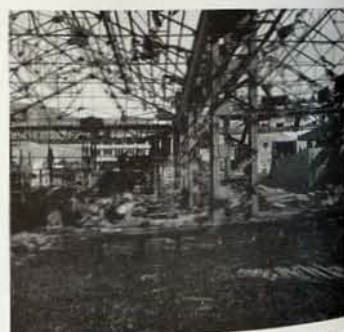
Remarks: Photo 172.

PHOTO 172.—Group 31, Building 11. Looking east along second column line from north end.

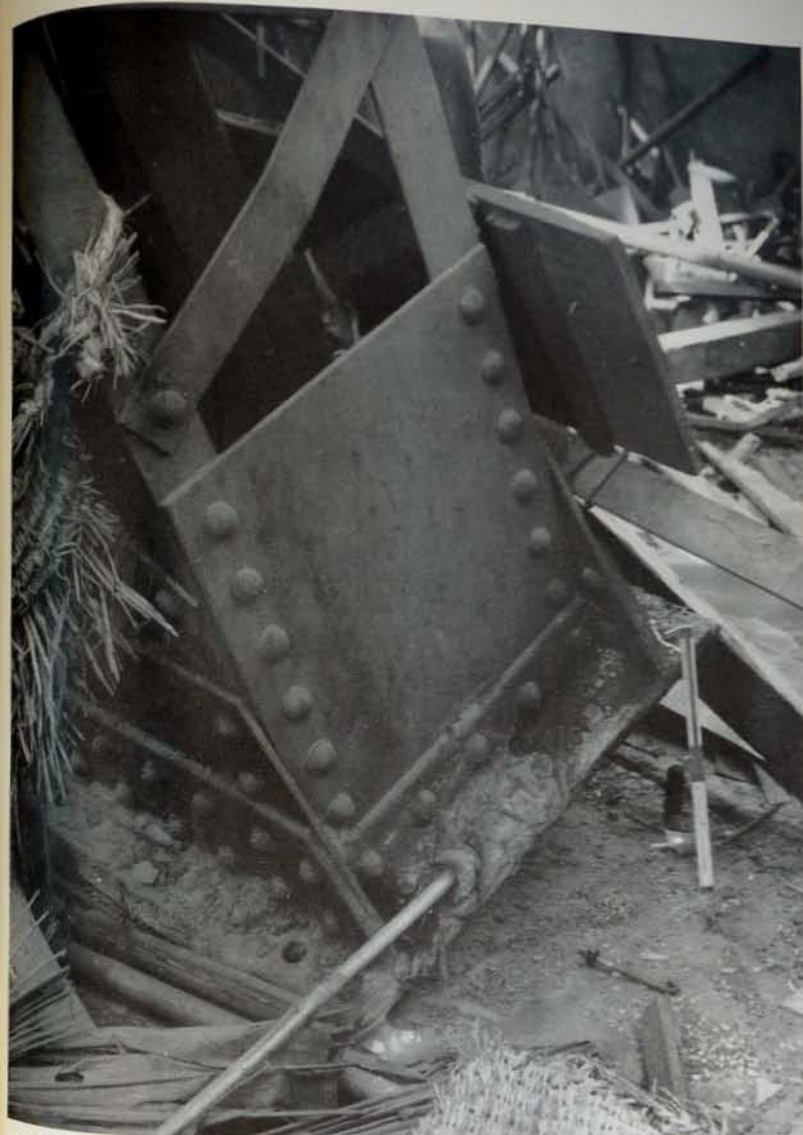
PHOTO 173.—Group 31, Building 1. Base of column tilted south. Typical of columns at north of building.

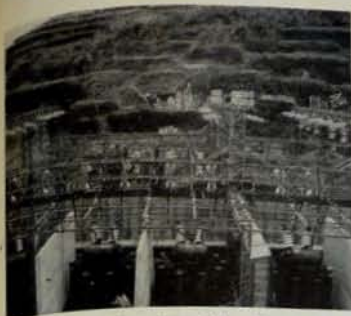
Remarks: Building located between 2 hills, north and south sides. Clay blast wall on east face. Figure 28; Photos 175 to 179.

Photo 175.—5,400 feet from GZ. Group 33. sub-station, transformers, and fire walls.

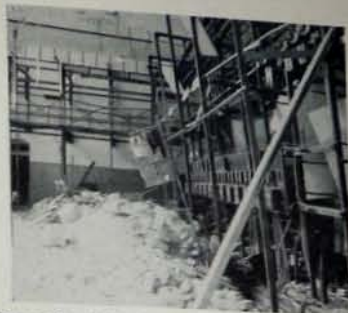
Construction	Damage			Description of damage
	Structural (percent)	Superficial (percent)	Cause	
Roof: Reinforced concrete arched panels	100	0	Blast	Thrust downward.
Trusses: Steel	100	0	do.	Thrust downward. Photo 176.
Columns: Brick	100	0	do.	
First floor: Reinforced concrete	0	0		
Foundation: 24-inch brick walls	0	0		
Exterior walls: 12- to 18-inch brick	100	0	Blast	East wall blown in; north wall demolished. Photos 178, and 179.
Windows: Wood sash	100	0	do.	
Contents: Switch boards and synchronous condenser.	0	10	Debris	Photo 176.

Photo 176.—5,400 feet from GZ. Group 33. Switch room, looking west.

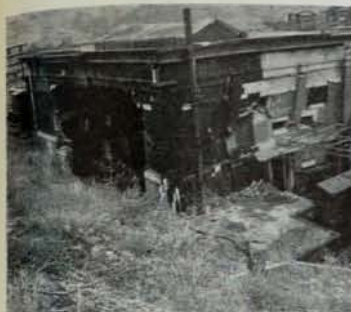
Photo 177.—5,400 feet from GZ. Group 33. North and east walls, looking southwest.

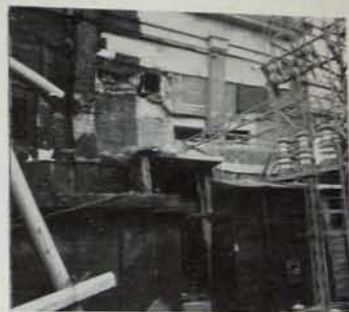
Photo 178.—5,400 feet from GZ. Group 33. North wall and blast walls.

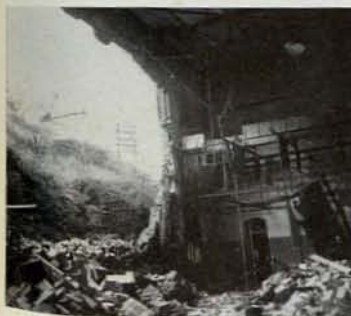
Photo 179.—5,400 feet from GZ. Group 33. East wall and bent roof trusses.

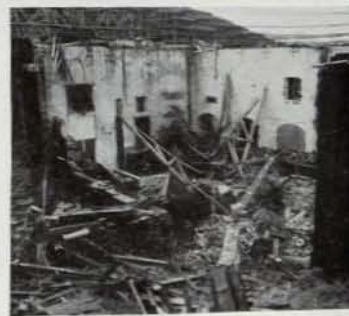
Remarks: Building completely demolished. Photo 180.

Photo 180.—5,400 feet from GZ. Group 33. Warehouse looking southwest.

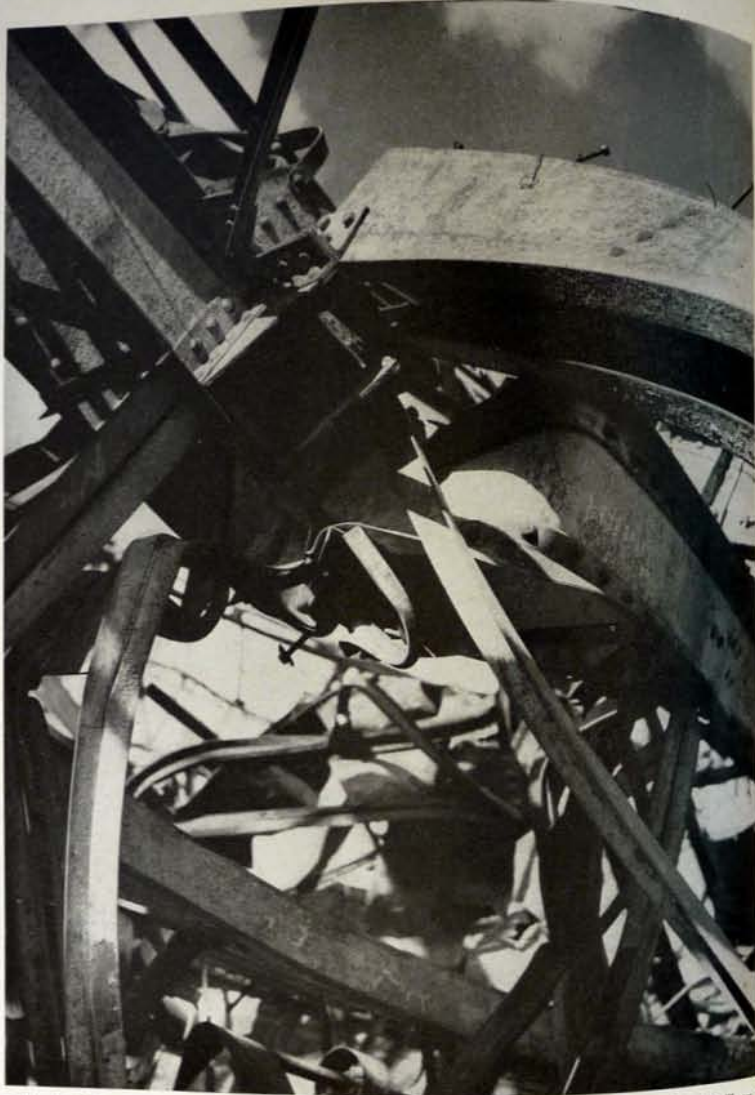
c. Fire was the principal cause of the damage in Building 1. In addition to the lumber stored in this building the floors were of heavy plank on timber girders, and all the wood was consumed by fire. The intense heat caused the steel columns to soften and collapse as shown in Figure 30 and Photos 181, 182, and 183. It was impossible to separate the extent of damage caused by blast and by fire, although it was estimated that 90 percent of the structural damage could be attributed to fire.

Construction	Damage			Description of damage
	Struc-tural (per-cent)	Super-ficial (per-cent)	Cause	
Roof: Corrugated iron on steel purlins.	0	100	Fire and blast	All roofing blasted from steel frame.
Trusses: Heavy steel	100	0	do	Steel trusses distorted by intense heat. Photos 181, 183, and 185.
Columns: Heavy steel	100	0	do	Columns distorted by blast and fire. Photos 182, 184, and 186.
Second floor: Wood flooring on wood timbers.	100	0	Fire	Completely burned.
First floor: Wood flooring on wood timbers.	0	0	do	Do.
Foundation: 14- by 14-inch piers, reinforced concrete.	0	0		No damage found.
Exterior walls: Corrugated iron	0	100	Blast and fire	Wall covering blasted from steel frame.
Windows: Glass set in steel frame	0	100		Completely destroyed.
Contents: Woodworking machinery; stocks of wood.	100	0	Fire	All contents destroyed by fire.

Photo 181.—5,600 feet from GZ. Group 35, Building 1. Mitsubishi Woodworking Plant. Top chord of Truss 7 distorted by intense fire and collapsed to first floor.

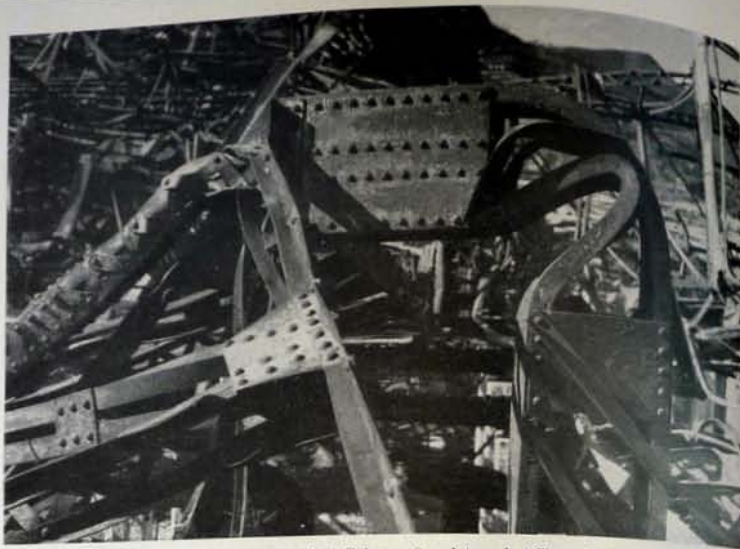
Photo 183.—Group 35, Building 1. Looking north at Columns 3 and 4, and at Truss B between Column Rows 2 and 3 (fallen to left).

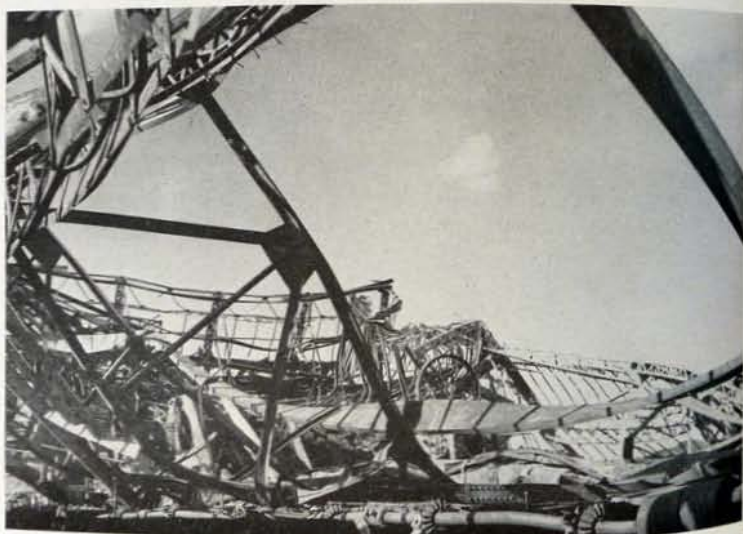
Photo 184.—Group 35, Building 1. Looking north at Truss 4, Column 5C at upper left, typical of collapsed Columns 2C, 3C, 4C, 5C, and 6C.

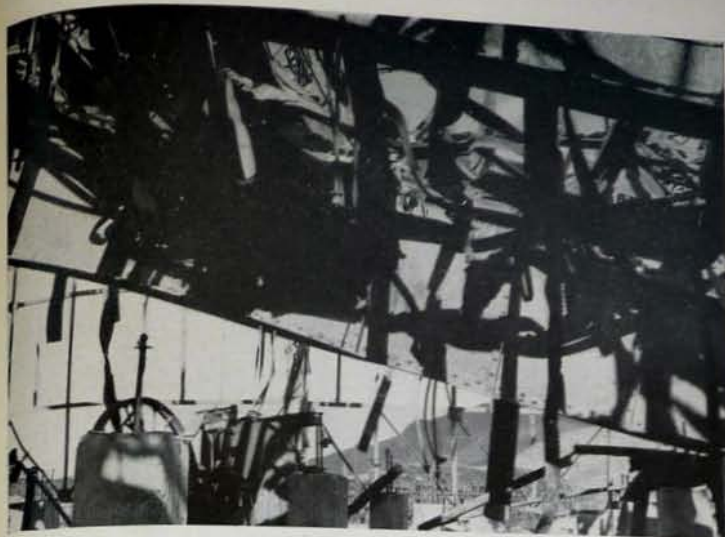
Photo 185.—Group 35, Building 1. Plate girder between Trusses 7 and 8. Typical of girders supporting roof over higher section of structure.

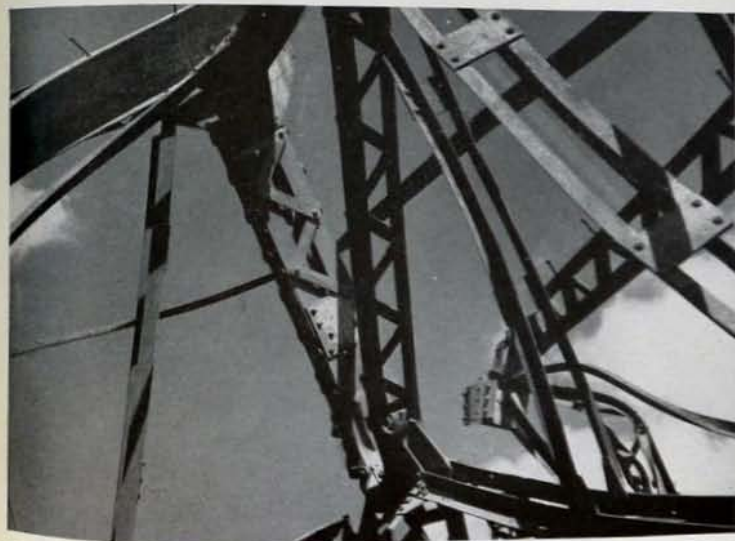
Photo 186.—Group 35, Building 1. Looking east at Truss B between Column Rows 2 and 6. Column 2B left of center.

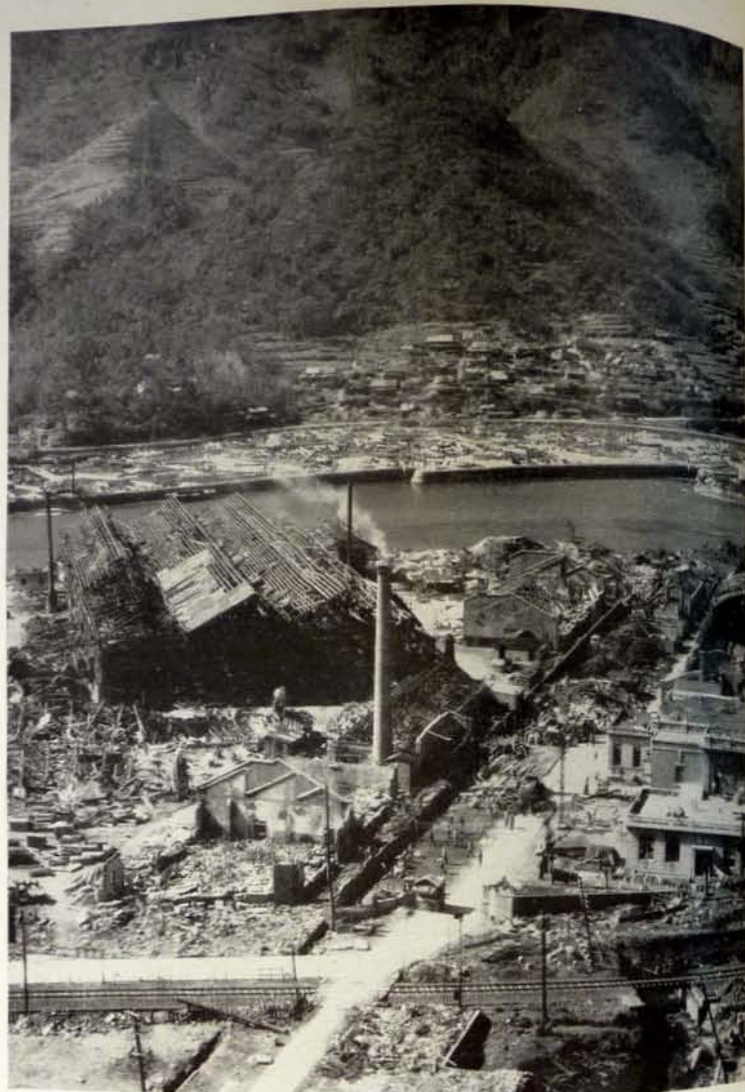
Remarks: No fire. Generators protected by reinforced concrete blast blocks 7 feet high. Photo 187.

Remarks: Almost complete collapse, with internal fire. Photo 187.

PHOTO 187.—5,000 feet from GZ. Group 36. Aerial view, looking west. Debris of Buildings 18 and 19 damaged by blast in foreground.

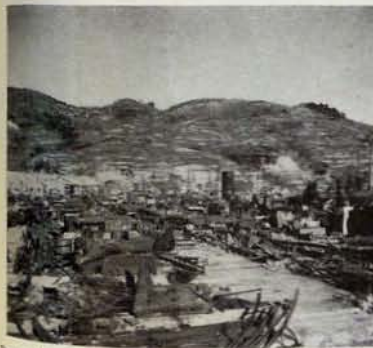
Remarks: Nothing left but floor and column bases—evidence of intense fire. Photo 189.

PHOTO 189.—5,900 feet from GZ. Group 36, Building 1. Looking east at general view of remains.

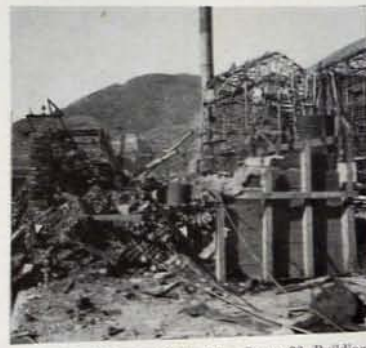
Remarks: Actually 2 small buildings, 1 housing transformers, the other being a roofed water basin. Photo 190.

PHOTO 190.—5,800 feet from GZ. Group 36, Building 2. Damaged substation.

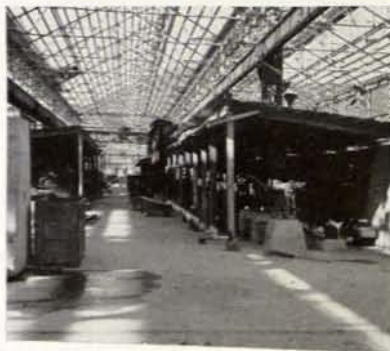
Remarks: Practically no structural damage; some fire evidence. Photos 191 to 194, inclusive, 197, 198, 199, 201, and 202.

PHOTO 192.—Group 36, Building 8. Blast walls and machines under temporary cover.

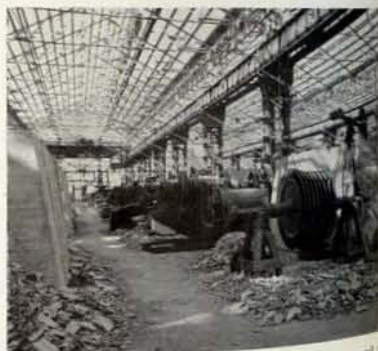
PHOTO 193.—Group 36, Building 8. Machine exposed to weather.

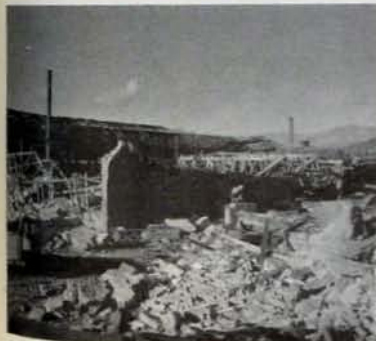
Remarks: Almost completely demolished. No fire. Photos 188 and 195.

PHOTO 195.—5,300 feet from GZ. Group 36, Building 11. Looking north at debris in foreground.

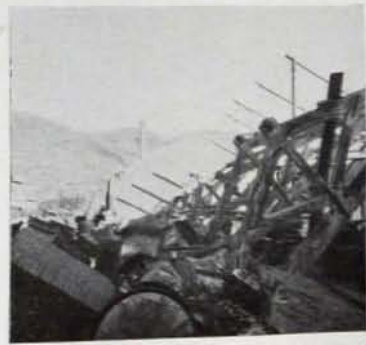
Remarks: Photo 196.

PHOTO 196.—4,800 feet from GZ. Group 36, Building 17. Interior view, looking east.

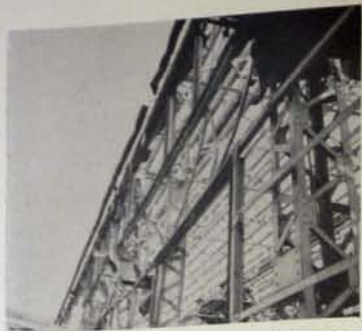
PHOTO 197.—Group 36, Building 8. Deformation of north row of columns.

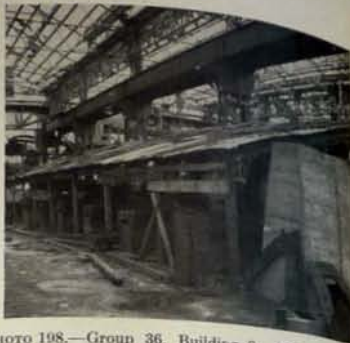
PHOTO 198.—Group 36, Building 8. Temporary cover over machines.

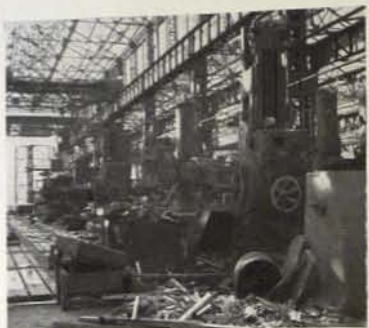
PHOTO 199.—Group 36, Building 8. Undamaged machine tools.

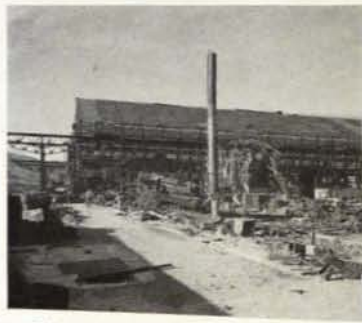
PHOTO 201.—Group 36, Building 8. Looking north at south side.

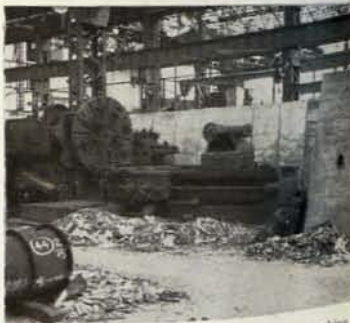
PHOTO 202.—Group 36, Building 8. Large machine with blast-wall protection.

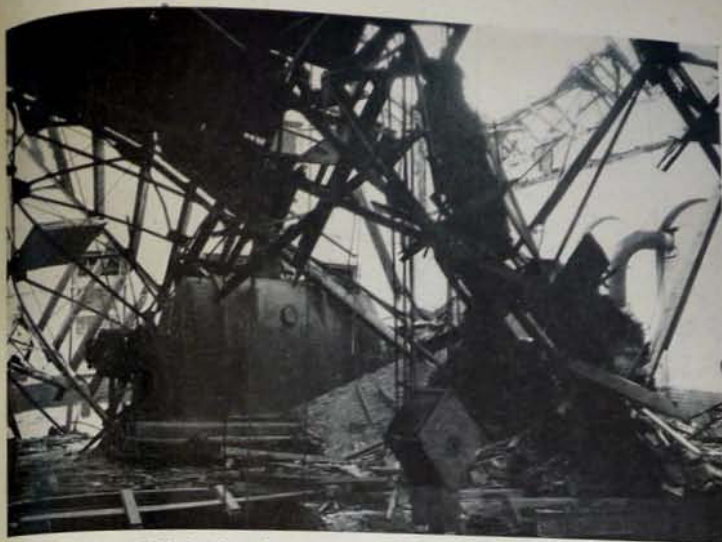
Construction	Damage			Description of damage
	Struc-tural (per-cent)	Super-ficial (per-cent)	Cause	
Roof: Wood—Turbine Rm; corrugated iron—Boiler Rm.	0	100	Blast	
Trusses: Steel	80	0	do	Photos 203, 204, 205, 208, and 210.
Columns: Brick	75	0	do	
First floor: Ground floor—reinforced concrete; turbine Rm Fl—reinforced concrete.	50	0	do	
Foundation: Reinforced concrete	0	0		
Exterior walls: 24-, 26-, and 28-inch brick.	75	0	Blast	Photos 205, 206, 207, and 208.
Windows: Wood sash	100	0	do	
Contents: Crane, turbine, and boiler	75	0	do	Boiler only. Photos 203, 204, 205, 209, and 210.

PHOTO 203.—6,700 feet from GZ. Group 39. Collapsed roof. Turbine room, looking west.

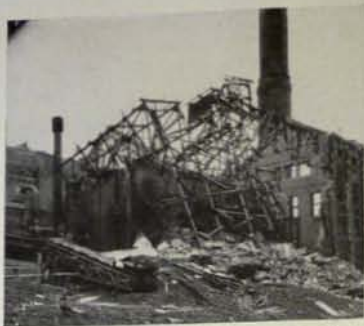
PHOTO 205.—6,700 feet from GZ. Group 39. Nagasaki generating station, looking southwest.

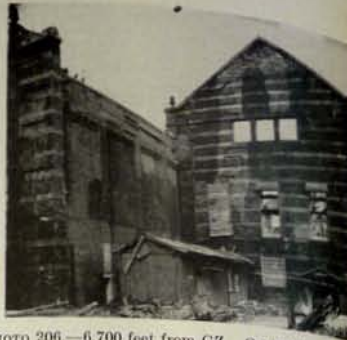
PHOTO 206.—6,700 feet from GZ. Group 39. of generating station, looking east. West wall

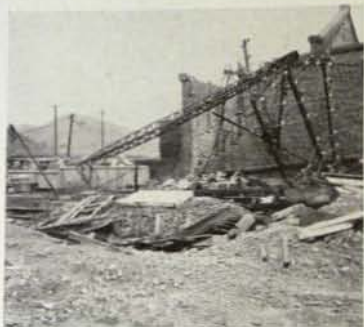
PHOTO 207.—6,700 feet from GZ. Group 39. Northeast corner steam plant, looking southeast.

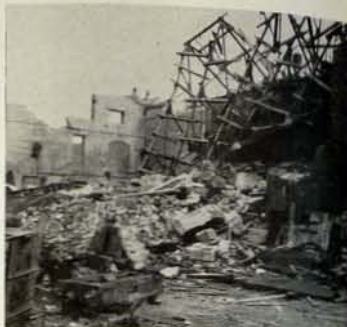
PHOTO 208.—6,700 feet from GZ. Group 39. Boiler plant, looking southeast.

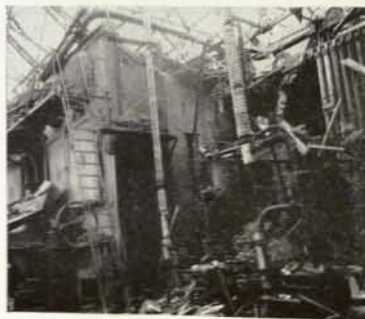
PHOTO 209.—6,700 feet from GZ. Group 39. Closeup of boilers, looking east.

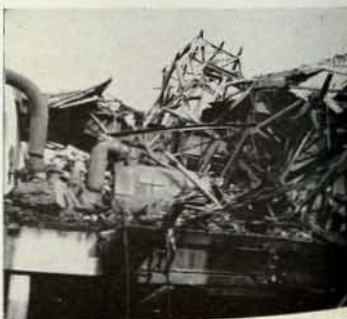
PHOTO 210.—6,700 feet from GZ. Group 39. Closeup of turbine and structural damage, looking east.

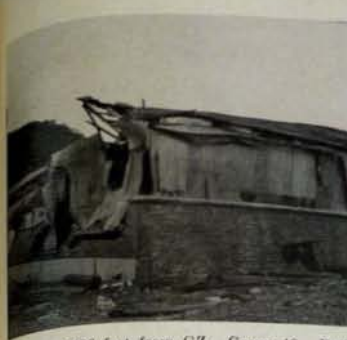
PHOTO 211.—6,400 feet from GZ. Group 40. Building 2A. Looking east at damaged building.

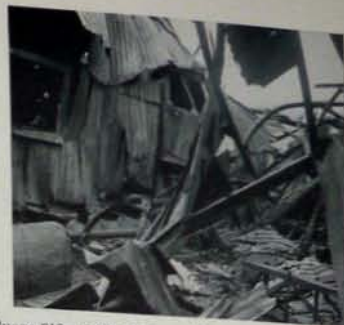
PHOTO 212.—6,300 feet from GZ. Building 1. Effects of intense fire on steel truss.

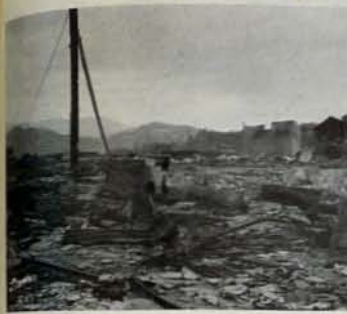
PHOTO 213.—Group 40. Building 9. Looking southwest at destruction by blast and fire.

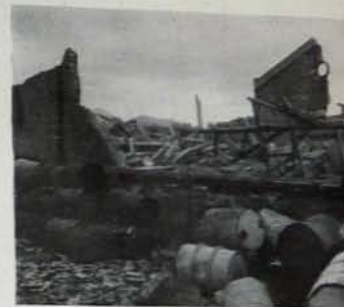
Remarks: Photo 214.

PHOTO 214.—6,500 feet from GZ. Group 40. Buildings 10 and 14. Destruction by blast only.

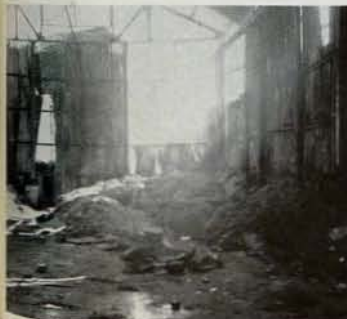
PHOTO 215.—Group 40. Building 2A. View of complete combustion of contents of storage shed.

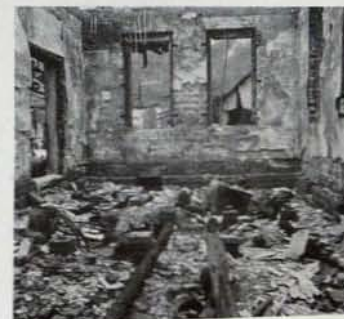
PHOTO 216.—Group 40. Building 8. Roof and contents destroyed by fire.

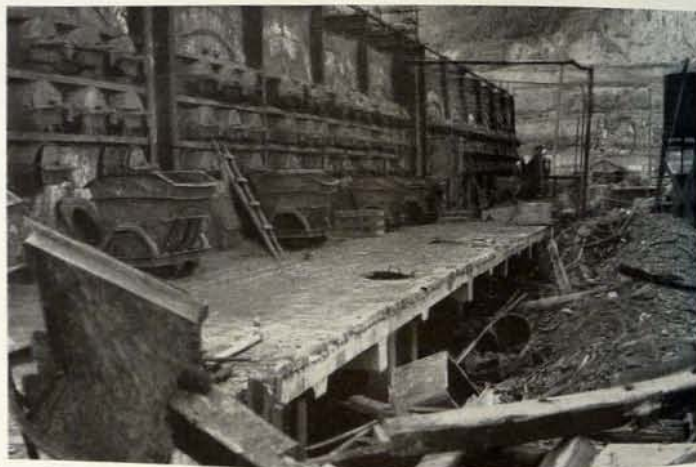
Photo 218.—Group 41. Looking east at south side of retorts. Destroyed building wall in foreground.

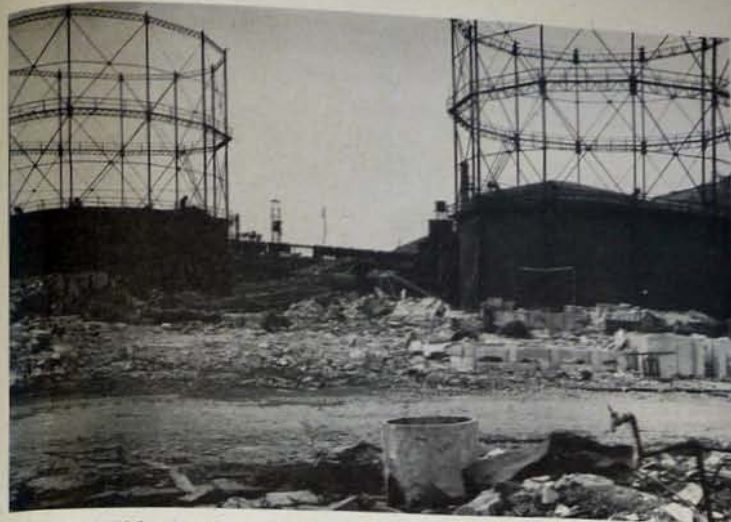
Remarks: Buildings demolished. Photo 219.

Photo 219.—6,400 feet from GZ. Group 41. General view looking north. Buildings 3 and 6 in foreground.

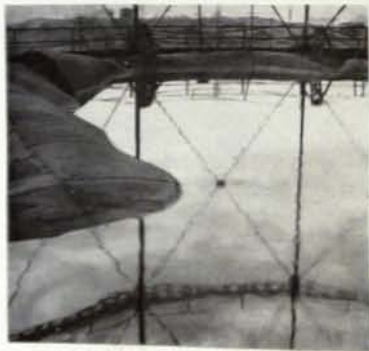
PHOTO 222.—6,100 feet from GZ. Group 41. View of top of damaged gas holder.

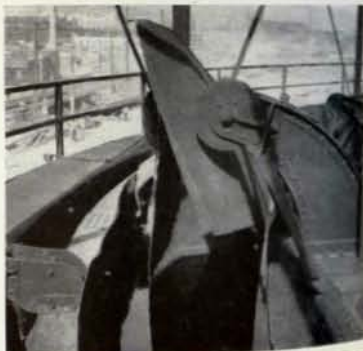
PHOTO 223. Group 41. Broken guide roller on inner gas holder.

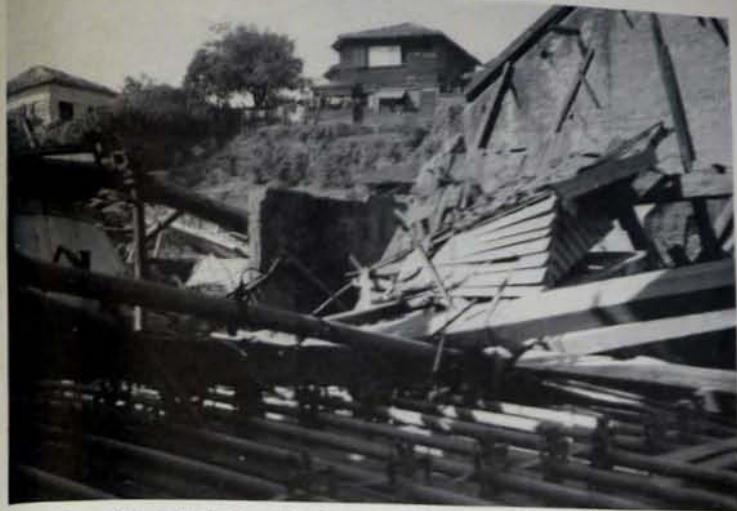
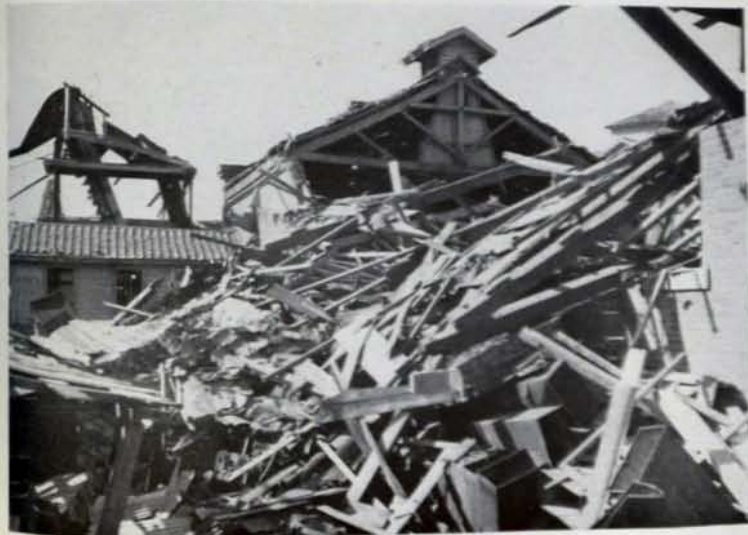
This group of buildings was originally reported to have housed a small engine works, but it was found by ground survey to contain ice-making machinery. It consisted of 3 buildings with 14-inch brick walls, light timber truss roofs, and concrete floors, located on the western side of the bay, 8,800 feet from GZ. It was completely demolished by blast from the atomic bomb. There was no evidence of fire in the wreckage of these buildings, the outlines of which were so obscure that no lay-out plan could be made. Photos 224 and 225 show remains of the structures.

PHOTO 224.—8,800 feet from GZ. Group 49. Ice plant. General view looking southwest.

PHOTO 225.—8,800 feet from GZ. Group 49. General view looking southwest.

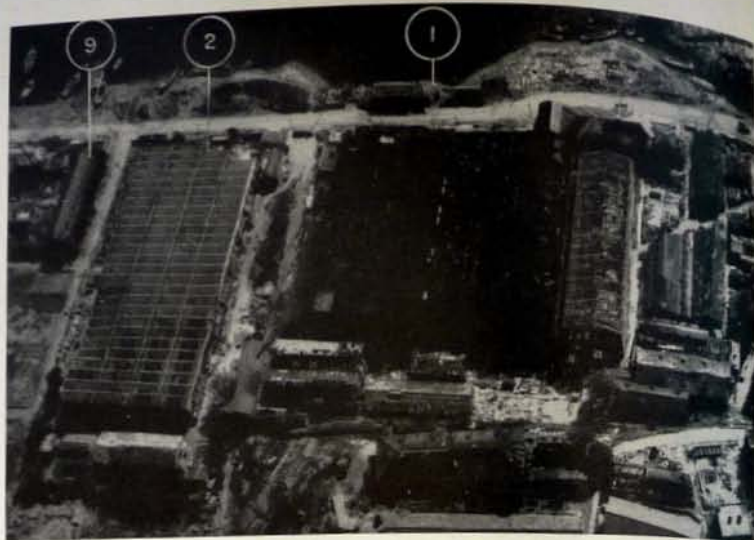
Remarks: All damage from blast of atomic bomb. No fire. Photos 226 and 227.

Photo 226.—9,700 feet from GZ. Group 50. Aerial view of Mitsubishi Electric Manufacturing Co. Looking southeast.

Photo 227.—9,700 feet from GZ. Group 50. Aerial view of Mitsubishi Electric Manufacturing Co. Looking north.

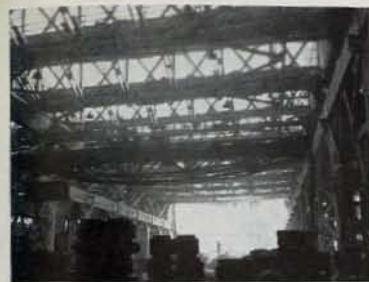
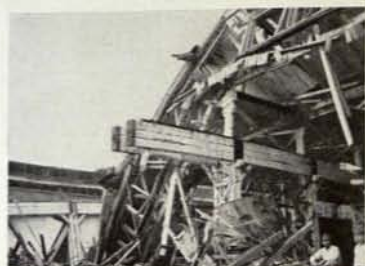
Construction	Damage			Description of damage
	Structural (percent)	Superficial (percent)	Cause	
Roof: Tar paper on wood sheathing	20	0	Blast	Photos 229 and 234.
Trusses: Heavy timber	20	0	do	
Columns: Built-up timber	20	0	do	
First floor: Concrete on earth				
Foundation: Concrete piers				
Exterior walls: Wood frame and siding	20	0	Blast	Photos 233 and 235.
Windows: Clear glass, wood frames	100	0	do	All window and roof light broken.
Contents: Assembly machinery

Remarks: Structural damage to roof members and columns caused by atomic bomb. No fire. Photos 229, 233, 234, and 235.

Photo 229.—9,500 feet from GZ. Group 50, Building 2. Typical construction, looking east.

PHOTO 233.—9,500 feet from GZ. Group 50. Aerial view of Building 2, looking northwest.

PHOTO 234.—9,500 feet from GZ. Group 50, Building 2. Showing damage to east end.

PHOTO 235.—9,500 feet from GZ. Group 50, Building 2. Fire wall in gables of saw tooth roof. Bamboo lath and plaster.

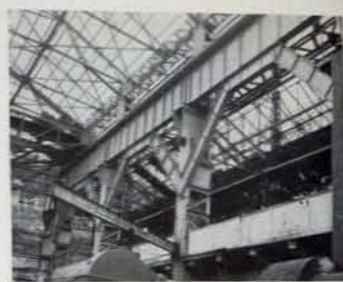
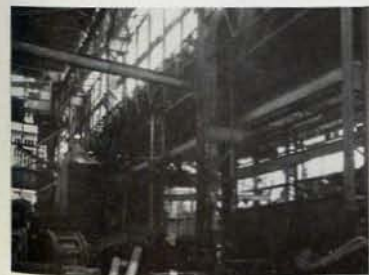
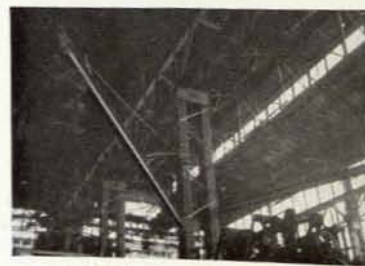
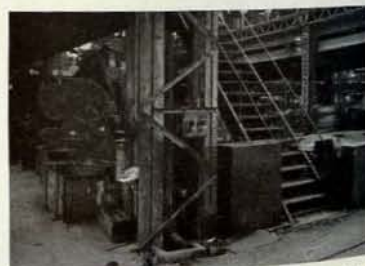
Construction	Damage			Description of damage
	Struc- tural (per- cent)	Super- ficial (per- cent)	Cause	
Roof: Corrugated iron on steel pur- lins.	0	10	Blast	Roofing blasted from purlins.
Trusses: Light steel.	0	0		Photo 230.
Columns: Built-up lattice type, box steel.	0	0		Photos 231, 232, 236, and 237.
Second floor: Concrete slab in 2 bays only.	0	0		
First floor: Concrete on earth.	0	0		
Foundation: Concrete piers.	0	0		
Exterior walls: Corrugated iron.	0	10	Blast	Siding loosened from steel frame.
Windows: Clear glass in steel frame.	0	0		All window and roof lights broken.
Contents: Light and heavy machine tools.	0	0

Remarks: No structural damage. Photos 230, 231, 232, 236, and 237.

Photo 230.—9,700 feet from GZ. Group 50, Building 1. Typical construction column lines A and B, looking northwest.

Photo 231.—9,700 feet from GZ. Group 50, Building 1. Typical column construction line J looking northwest.

Photo 232.—9,700 feet from GZ. Group 50, Building 1. Typical column construction line G, looking northwest.

PHOTO 236.—9,700 feet from GZ. Group 50, Building 1. Typical construction column lines D, E, F, and G, looking east.

PHOTO 237.—9,700 feet from GZ. Group 50, Building 1. Typical construction column line C, looking northwest.

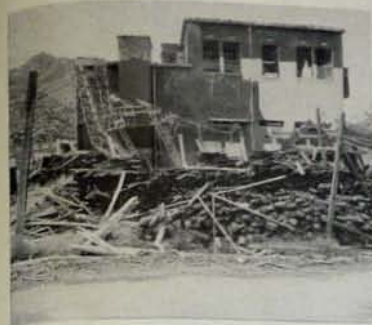
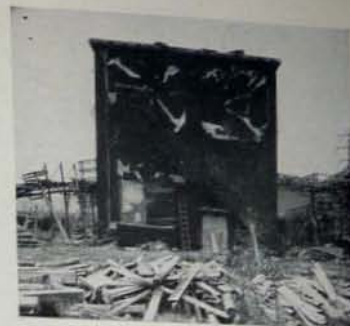
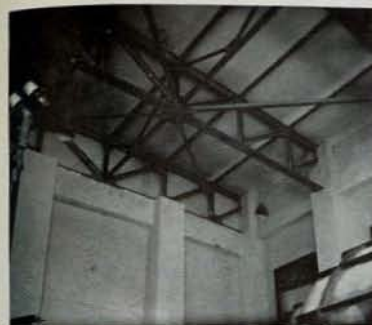
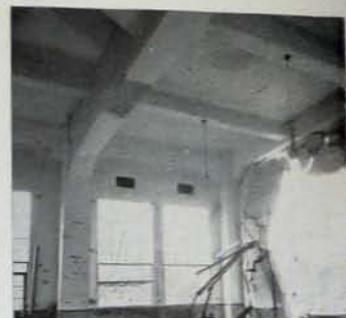
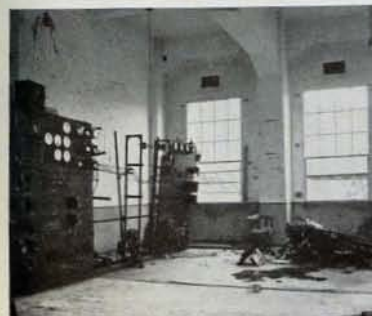
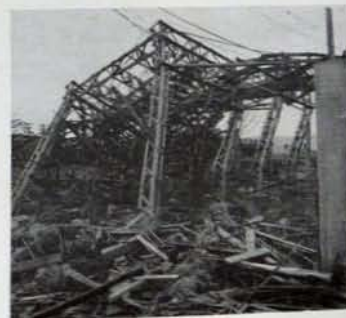
This was a single building located 3,600 feet south of GZ (Photos 238, 239). It was of unusually heavy concrete-and-steel construction and with-

stood the blast well. The north wall between the second floor and the roof was blown inward by the force of the blast, (Photos 239 and 241). Between the first and second floors, the north wall was fractured in several places (Photos 239 and 241).

Construction	Damage			Description of damage
	Structural (percent)	Superficial (percent)	Cause	
Roof: Reinforced concrete slab on reinforced concrete beams and girders	0	0		Photo 242.
Trusses: Steel—under second floor only	0	0		
Columns: Reinforced concrete	0	0		
Second floor: Reinforced concrete slab on reinforced concrete beams and girders. Also reinforced concrete slab on steel trusses.	0	0		
First floor: Reinforced concrete				North wall above second floor blasted in. Photos 239 and 241.
Foundation: Reinforced concrete	30	0	Blast	
Exterior walls: 8-inch reinforced concrete.				
Interior walls: Lath and plaster	20	0	do.	
Windows: Steel sash	0	100	do.	All glass gone.
Contents: Control equipment and switchboards.

Remarks: Photos 238 to 243, inclusive.

PHOTO 238.—3,600 feet from GZ. Group 51. Takenokubo Substation. Looking west.

PHOTO 239.—3,600 feet from GZ. Group 51. North elevation, looking south.

PHOTO 240.—3,600 feet from GZ. Group 51. Typical construction. Condensor room.

PHOTO 241.—3,600 feet from GZ. Group 51. Typical construction. Control room.

PHOTO 242.—3,600 feet from GZ. Group 51. Interior of switch room.

PHOTO 243.—3,600 feet from GZ. Group 51. South tower twisted and trusses bent.

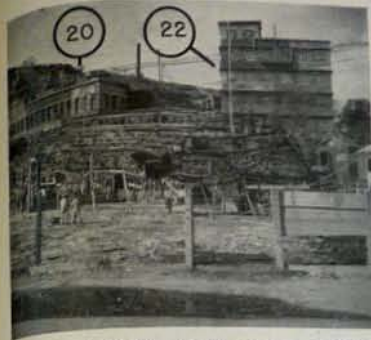
Photo 249.—Group 52. Looking west at Buildings 20 and 22.

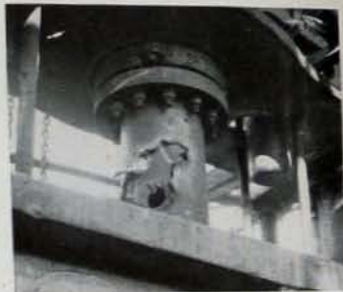
Photo 252.—Group 52, Building 13. Fragment damage to 600-ton hydraulic press. Bomb exploded in air 20 feet from the machine.

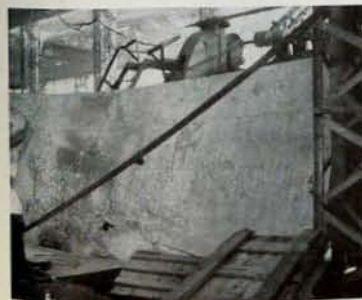
Photo 253.—Group 52, Building 15. Eight-spindle drill saved from damage by blast walls. Five-hundred-pound bomb exploded 15 feet from the machine.

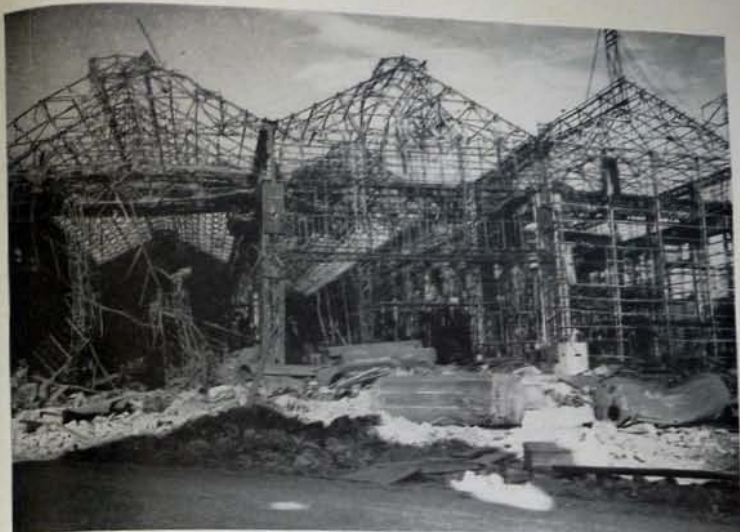
PHOTO 257.—Group 52, Building 15. Column and trusses distorted by HE bombs.

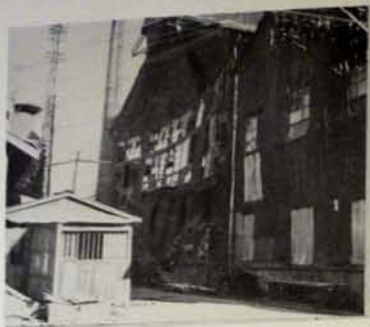
PHOTO 263.—11,500 feet from GZ. Group 52, Building 12. North wall of Section 12 C bowed in and roof sagging from atom bomb blast.

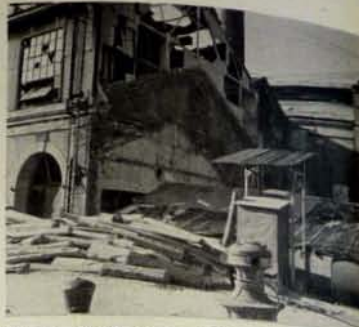
PHOTO 264.—12,200 feet from GZ. Group 52, Building 1. Superficial damage to roofing and siding of Section 1 A by atom bomb blast.

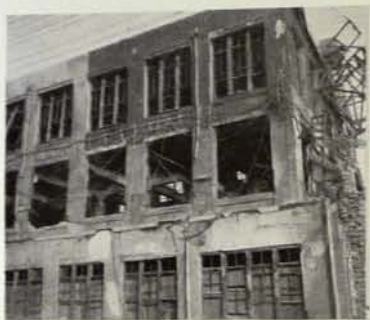
PHOTO 265.—Group 52, Building 17. South end of Section 17 D damaged by HE bomb.

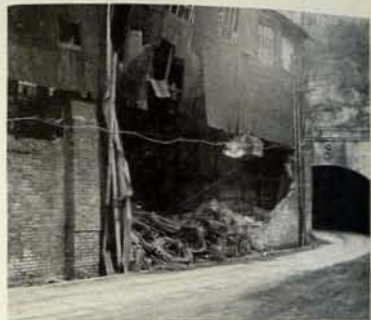
PHOTO 266.—12,100 feet from GZ. Group 52, Building 1. North wall of Section 1 C blown in by atomic bomb.

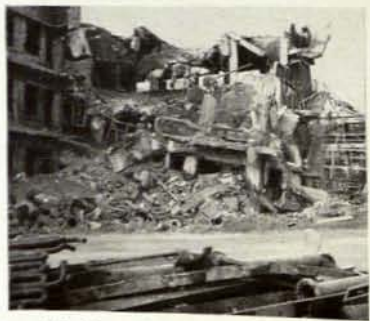
PHOTO 267.—Group 52, Building 14. Wing of building collapsed after corner was blown in by very near miss of HE bomb.

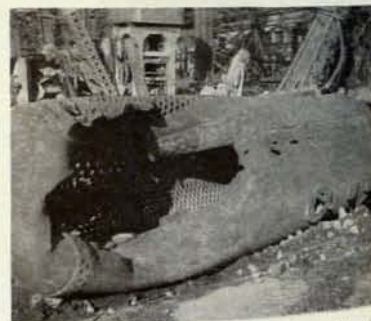
PHOTO 268.—Group 52. New boiler (1½" thick plate) under construction destroyed by blast and fragments from near miss.

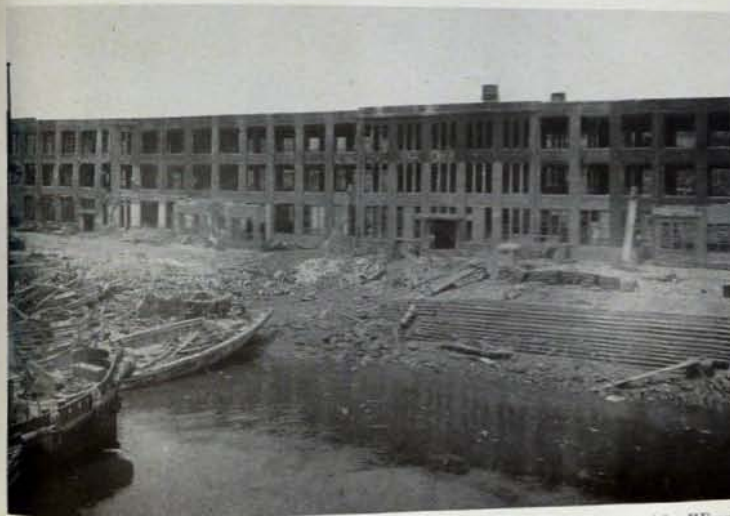
PHOTO 270.—Group 52, Building 17d. Jap photo dated 7 Aug. 1945. Office building damaged by HE and almost completely burned out.

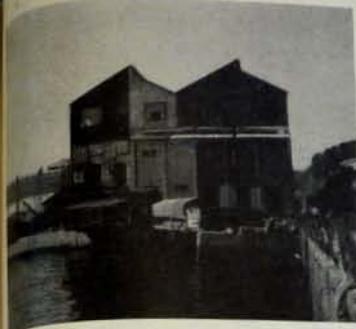
Remarks: No structural damage. Photos 272 and 273 (typical).

Photo 272.—13,800 feet from GZ. Group 54, Building 1. General view looking west. Mitsubishi Dock Yard.

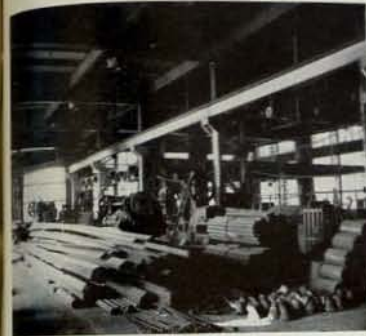
Remarks: No structural damage. Photos 274 and 275.

Photo 274.—Group 54, Building 2. Interior view looking west at typical construction.

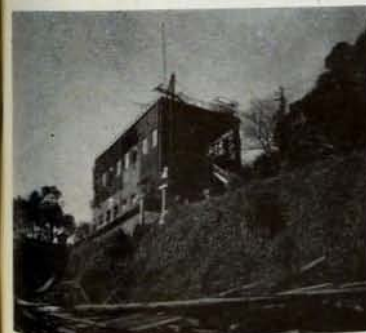
Remarks: No structural damage. Photo 276.

Photo 276.—Group 54, Building 3. General view looking west.

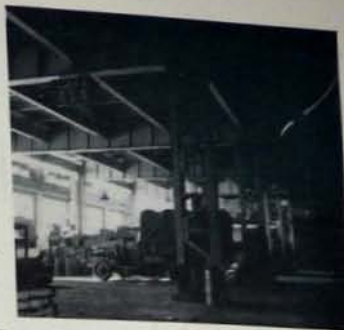
Photo 273.—Group 54, Building 1. Interior view looking west at typical construction.

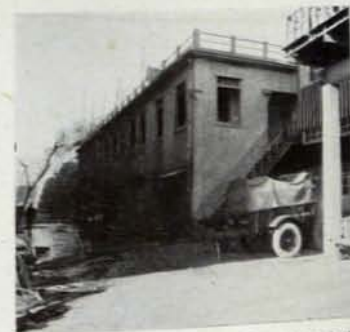
Remarks: No structural damage. Photo 277.

Photo 277.—Group 54, Building 4. General view looking west.

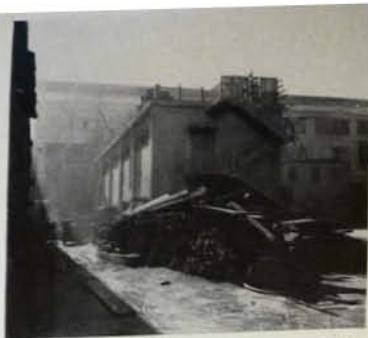
Remarks: No structural damage. Photo 278.

Photo 278.—13,700 feet from GZ. Group 54, Building 5. General view looking south.

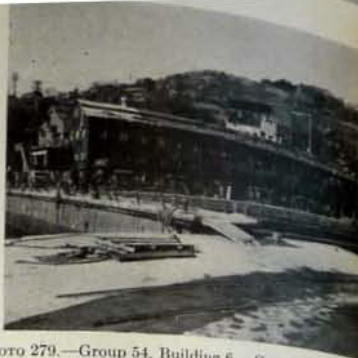
Remarks: No structural damage. Photo 279.

Photo 279.—Group 54, Building 6. General view looking northwest. Building 3 above hill.

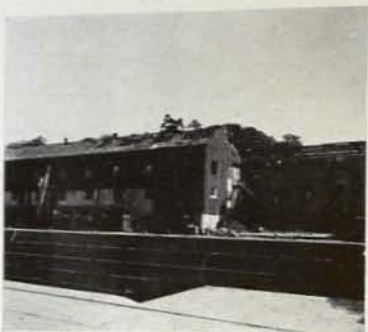
Remarks: No structural damage. Photo 280.

Photo 280.—13,600 feet from GZ. Group 54, Building 7. General view looking east.

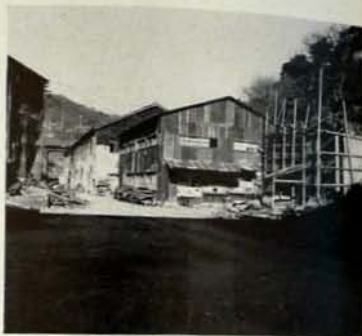
Remarks: No structural damage. Photo 281.

Photo 281.—Group 54, Buildings 8 and 9. General view looking north.

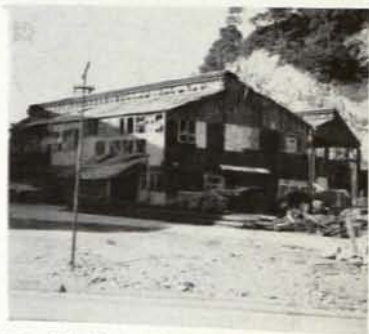
Remarks: No structural damage. Photo 282.

Photo 282.—Group 54, Building 10. General view looking west. Damage by atomic bomb.

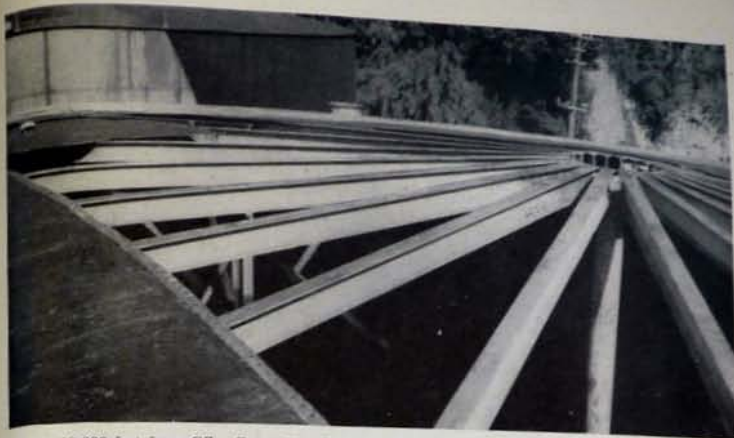
b. No damage was sustained by any of these structures from blast or fire from the atomic bomb, but one brick building with a wooden roof (No. 19) and one storage tank near by (No. 20) were damaged by a high-explosive bomb. Approximately 60 percent of the building roof and 50 percent of the east and south walls were structurally damaged. Photo 289 shows the damage

Photo 289.—19,000 feet from GZ. Group 58. Looking north at roof damage to Tank 20, Kuraki Point Oil Storage.

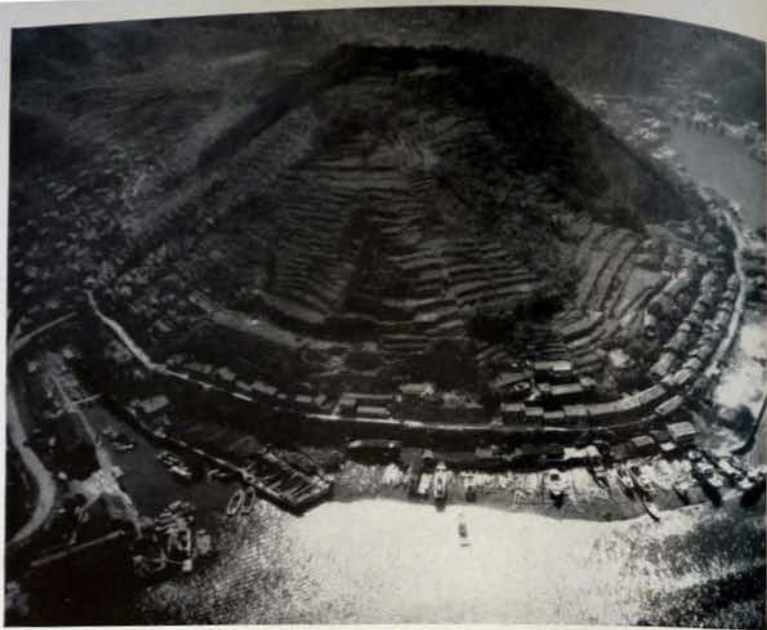
c. These buildings were located between 16,200 and 16,800 feet south of GZ. The damage from the atomic bomb was minor, consisting of broken window glass and a small amount of displaced siding. Photos 294 and 295 show general views of these buildings.

Photo 294.—16,200 feet from GZ. Group 89. Aerial view of Mitsubishi Boat Shop.
